Compensation System

Sidel S1 & S2 Dual- New Compensation System

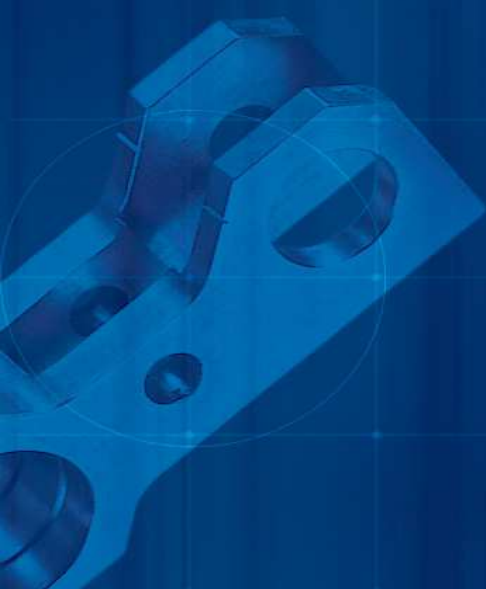
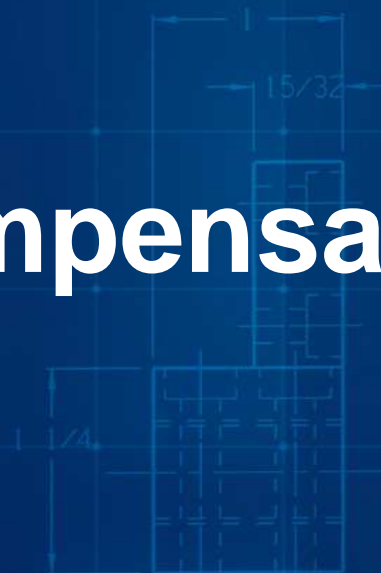
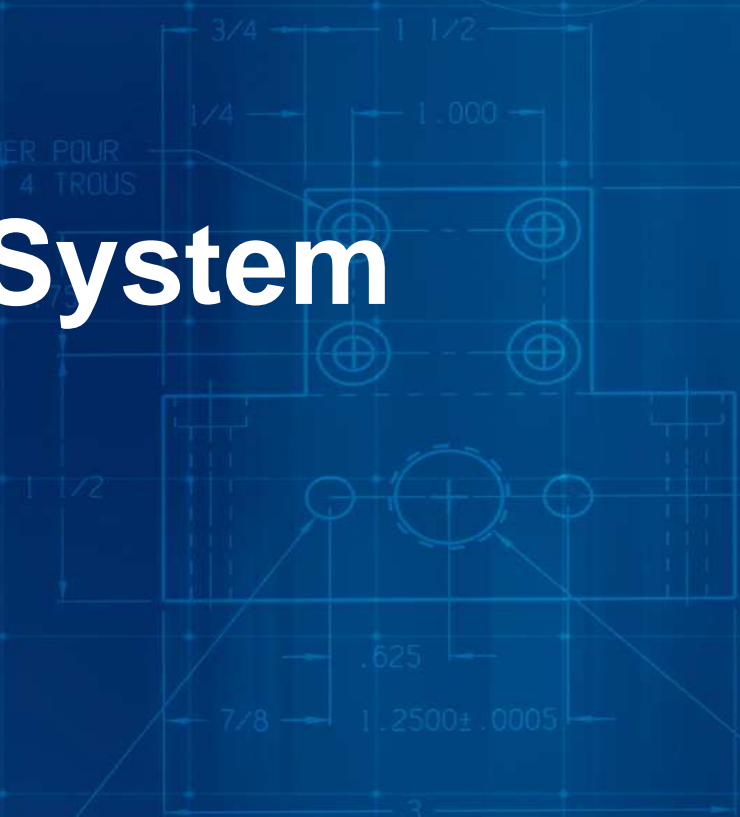
- Belleville washer breaks
- Grooves eventually appears on bolt and Belleville washer get stuck in these grooves.
- Bar assembly is time consuming (10+ min./bar)
- Risk of making mistake in quantity of Belleville washers used and their orientation

- Removal of all Belleville washers and bolts
- Use of specifically-designed rubber pads
- Unit fully assembled within 2 minutes
- Quick-Change solution
- Low profile which fits in all machine types (S1 SBO4 to S1 SBO24 & S2 Dual Cavities)
- CSD and Heat Set compliant (up to 392°F/200°C)

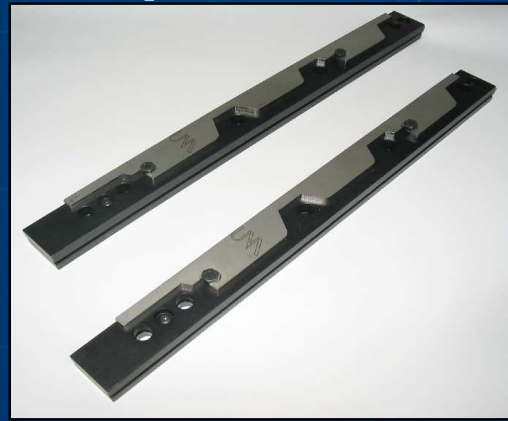
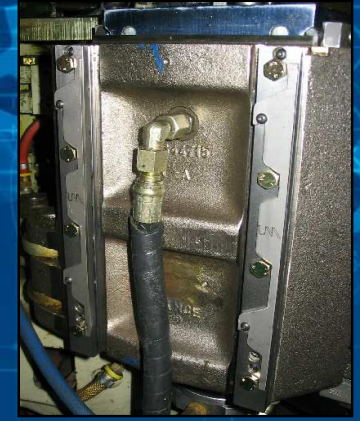
- Longer preventive maintenance
- Frequent downtime
- Mold not locking properly
- Parting line (flash) on bottle
- Process issues

- Increased life expectancy
- Reduced machine downtime and maintenance
- Direct and easy replacement
